## Structure S-46

Structure Restoration - Concrete Repair

### **Project Location:** Jupiter, Florida

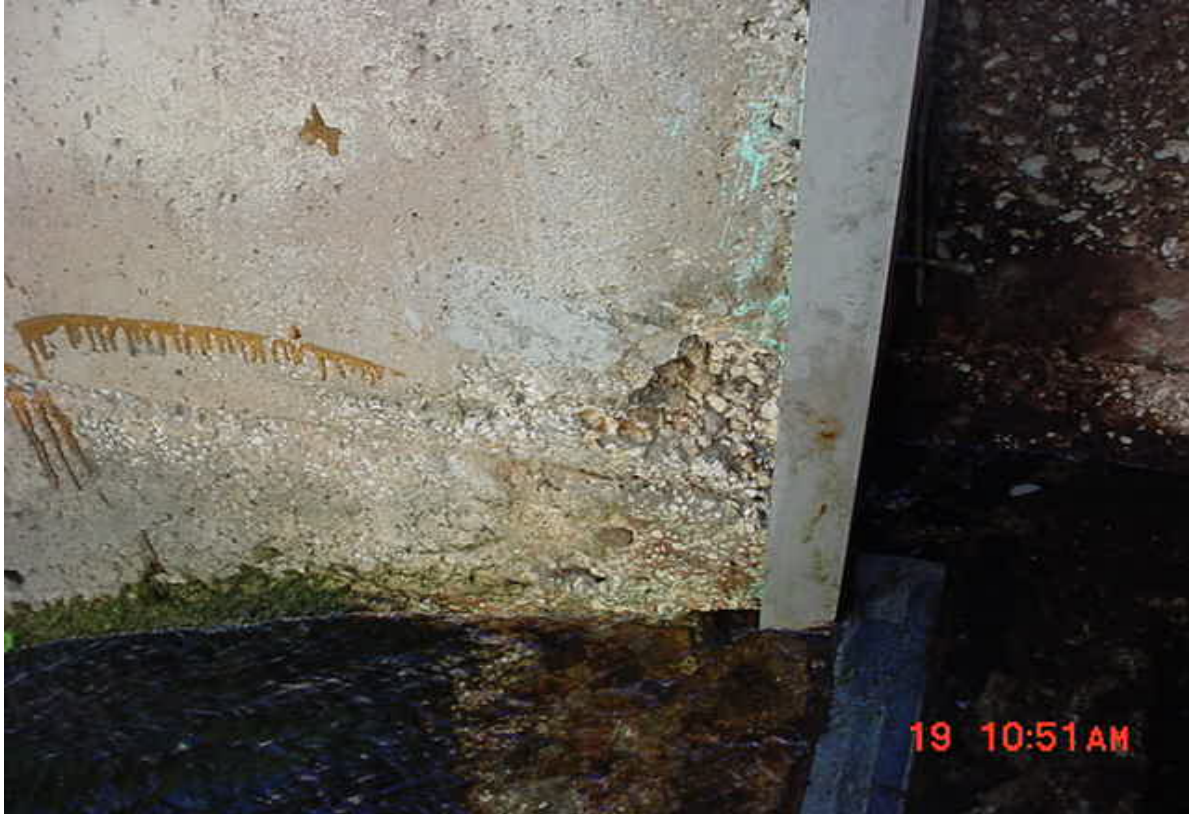
Structure S-46 in Jupiter, Florida maintains approximately a 15 foot water elevation difference on a canal. In February of 2002, the structure began “piping” water under the structure and carrying the substrate from under the structure with it. UESI was contracted to perform emergency services to core drill the floor and install a urethane repair product, “Mountain Grout,” to repair areas of concern. The divers core-drilled 2-inch-diameter holes in the floor of the structure then pumped the urethane repair material through ports to shut off the “piping.”

In 2003, UESI was contracted to repair a smaller piping problem which was not carrying substrate with it. In 2004, UESI was contracted to repair spalls behind a gate track with active water leaks. Elements of work included preparation of the spall with lightweight demolition equipment and application of a corrosion inhibitor to the existing rebar. A urethane based product was used to shut off the leaks to allow for proper repair. The patch material was a polymer-modified cementitious grout.
